# Foundation Repairs at Port Credit Library – Ward 1- Community Meeting Presentation

March 24, 2022

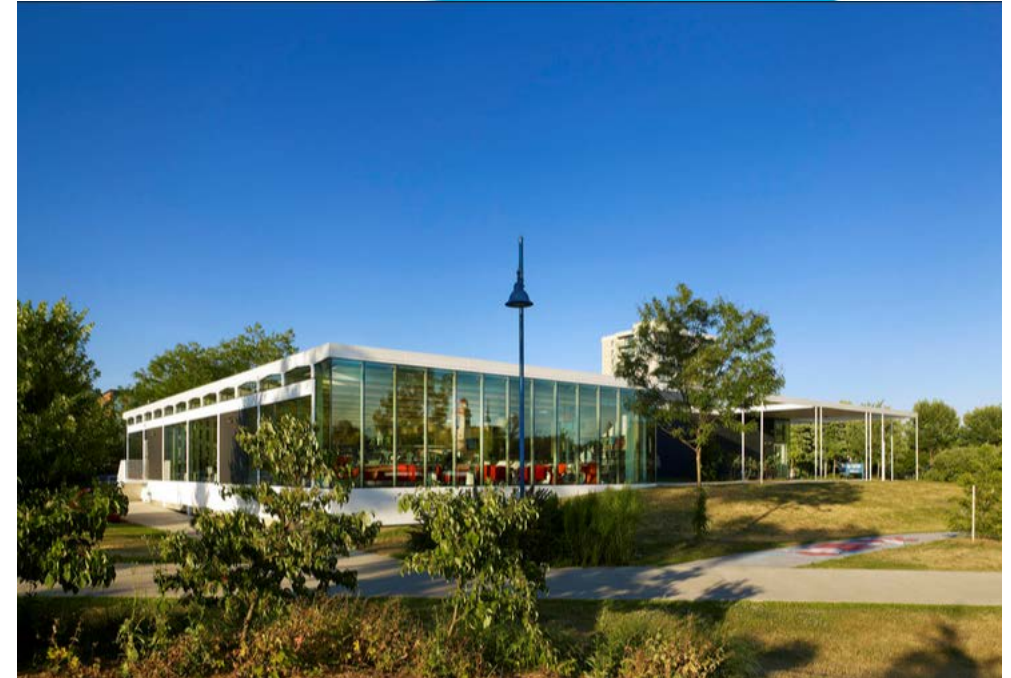
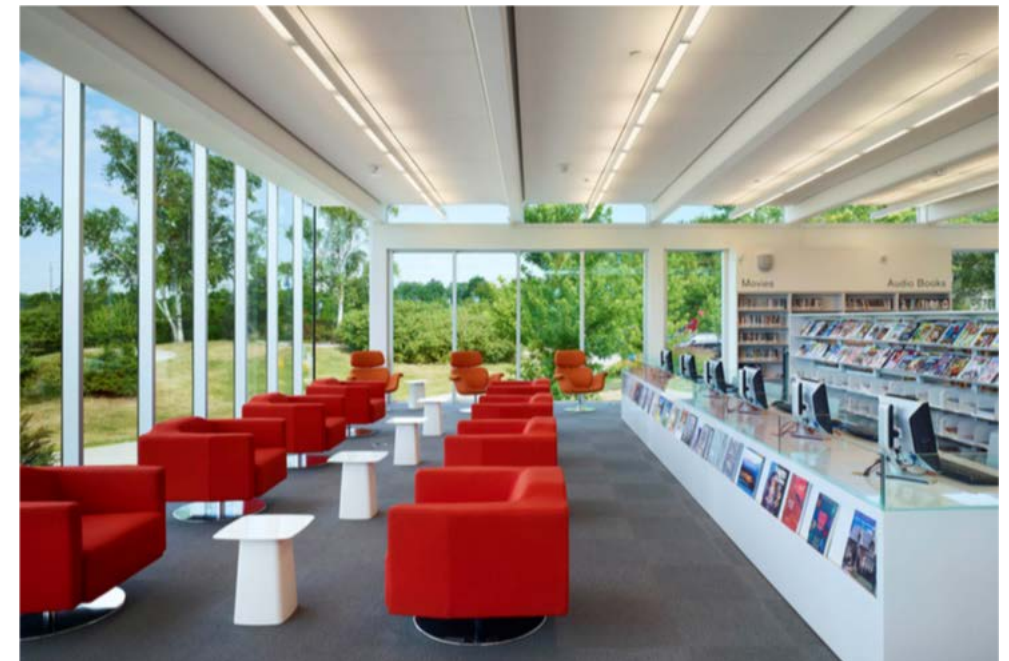
- The building sits on a post and beam concrete foundation grid with a partial 3 foot crawl space and rests on 27 piers (caissons) that are driven deep into the landfill.
- The building and site underwent a major renovation in 2009 and reopened to the public in 2011.
- There are no records on file to indicate issues with the foundation system when the building was redeveloped over 10 years ago.

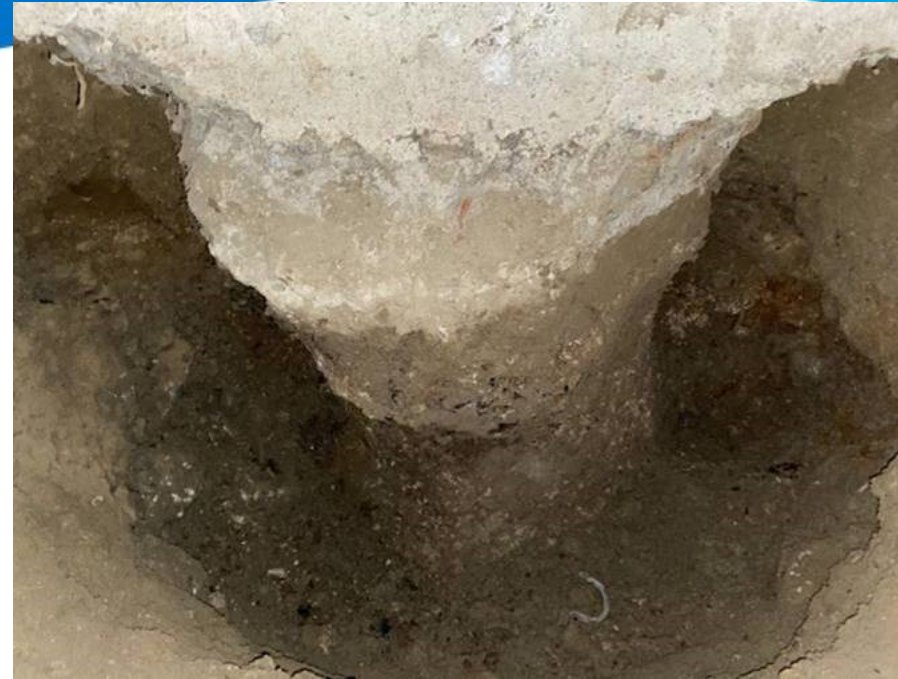
## Exposed Caisson D9

A close-up photograph of a concrete pile foundation. The pile is cylindrical and shows signs of weathering and discoloration. It is surrounded by a trench filled with dark, moist soil. At the base of the pile, there is a dark, reflective area that appears to be water or a void, possibly indicating a leak or a void in the foundation. The surrounding soil is uneven and appears to be a mix of dirt and small stones.

A close-up photograph of a concrete structure, likely a foundation or wall, showing significant signs of aging and damage. A large, irregular crack runs diagonally across the lower portion of the frame. The concrete surface is heavily textured, with areas of spalling, peeling, and exposed aggregate. The color is a mix of light gray and brownish-tan, suggesting moisture or staining. The overall appearance is one of severe structural wear and tear.

- 2013- Visual deterioration of caissons supporting the building structure was noticed as part of routine building condition assessment
- 2013- 2016 – A number of structural assessments were completed to ensure the building is structurally stable and safe for public use
- 2016- Installation of foundation monitoring system as per structural engineer recommendations
- 2016- Completion of Pilot Helical Pile project to develop a long term feasible solution for caisson repair
- Spring 2021- Detailed structural assessment noted considerable loss of cross section in 4 sample caissons . Structural report recommended the closure of Library for public use

- Testing results indicated considerable loss of cross-section on 4 caissons during the past 5 year timeline.
- Although no obvious signs of distress or structural failures were observed, the consultant noted that the remaining life of the foundation cannot be determined and is deemed to be exhausted.
- Foundation upgrades need to be undertaken because of the unknown rate of deterioration of the caissons.
- It was recommended that the Library be closed for public use; however, it may stay open for maintenance and limited staff until the foundations have been upgraded.

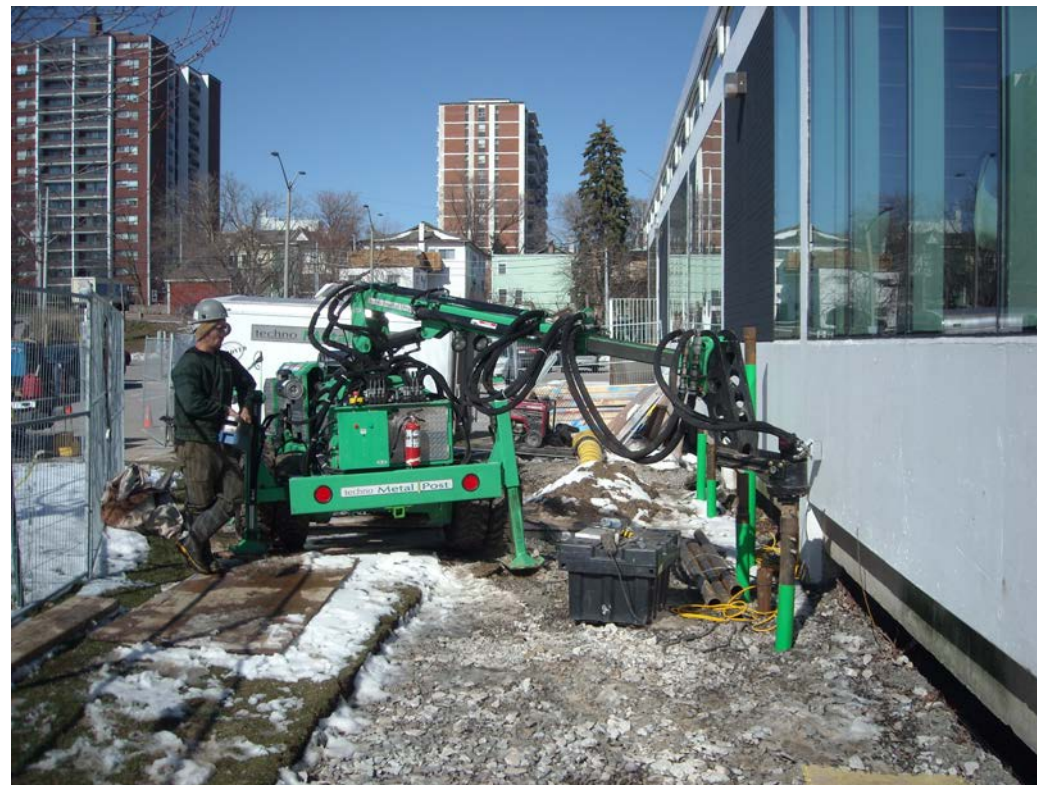
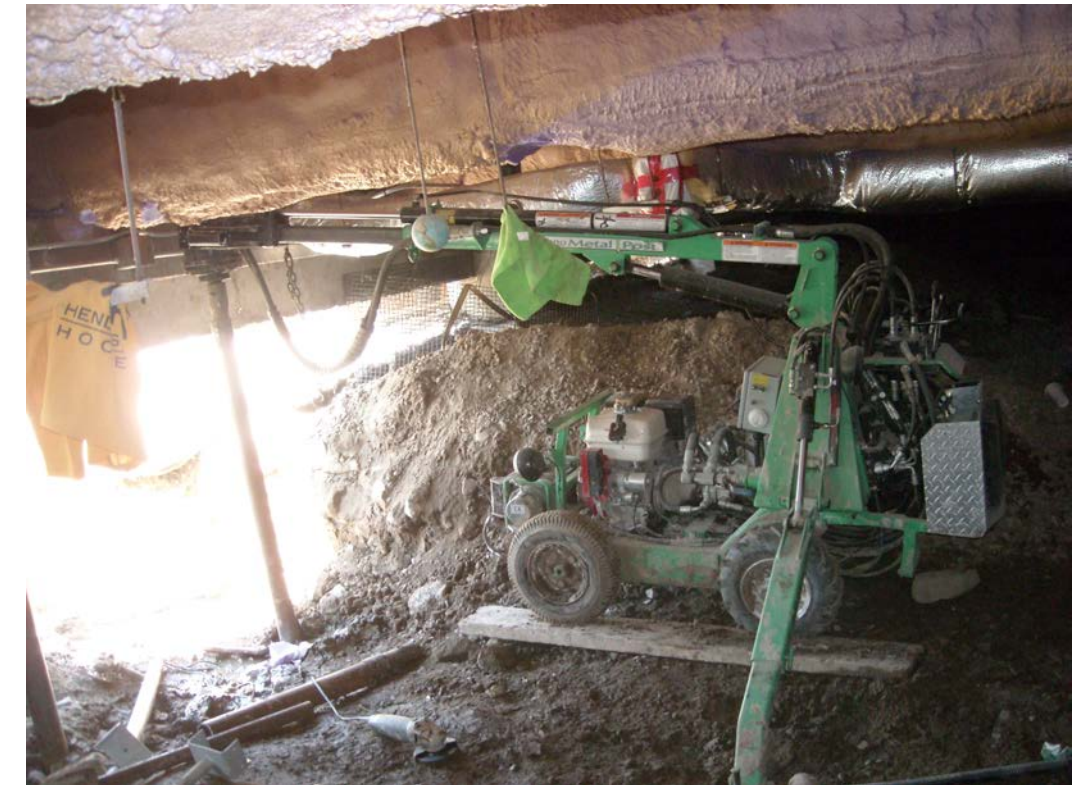
- Pilot project was successfully completed in 2016 on 3 caissons
- Deemed an acceptable long term foundation repair solution
- Solution addresses site constraints including high ground water table, restricted site access and contaminated soil

Installation of piles – exterior and under building crawl space
